**DEPARTMENT OF TRANSPORTATION****DIVISION OF ENGINEERING SERVICES**

Contract #: 04-0120F4Cty: SF/ALA Rte: 80 PM: 13.2/13.9File #: 69.28**WELDING INSPECTION REPORT****Resident Engineer:**Pursell, Gary**Address:** 333 Burma Road**City:** Oakland, CA 94607**Report No:** WIR-006057**Date Inspected:** 12-Feb-2009**Project Name:** SAS Superstructure**OSM Arrival Time:** 645**Prime Contractor:** American Bridge/Fluor Enterprises, a JV**OSM Departure Time:** 1845**Contractor:** Zhenhua Port Machinery Company, Ltd (ZPMC), Changxing Island **Location:** Shanghai, China**CWI Name:** See Below**CWI Present:** Yes No**Inspected CWI report:** Yes No N/A**Rod Oven in Use:** Yes No N/A**Electrode to specification:** Yes No N/A**Weld Procedures Followed:** Yes No N/A**Qualified Welders:** Yes No N/A**Verified Joint Fit-up:** Yes No N/A**Approved Drawings:** Yes No N/A**Approved WPS:** Yes No N/A**Delayed / Cancelled:** Yes No N/A**Bridge No:** 34-0006**Component:** OBG Fabrication**Summary of Items Observed:**

**OBG Bay 7**

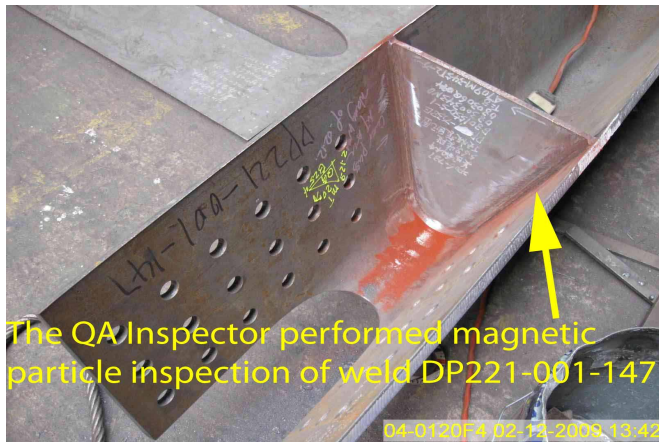
This QA Inspector performed random final visual and magnetic particle (MT) inspections of OBG diaphragm plate weld DP221-001-147. ZPMC magnetic particle Inspectors had previously completed magnetic particle inspections of this weld. The QA Inspector observed the weld appear to comply with project specifications and the Inspector indicated lot number B254 adjacent to the weld. For additional information on these inspections see the TL6028 Magnetic Particle Test Report and the photograph below.
